# Interagency Aviation SAFETY ALERT

No. IASA 21-01

**Subject: Unmanned Aircraft Systems (UAS) DJI M600 Mishaps**

**Area of Concern: Airworthiness Inspection.**

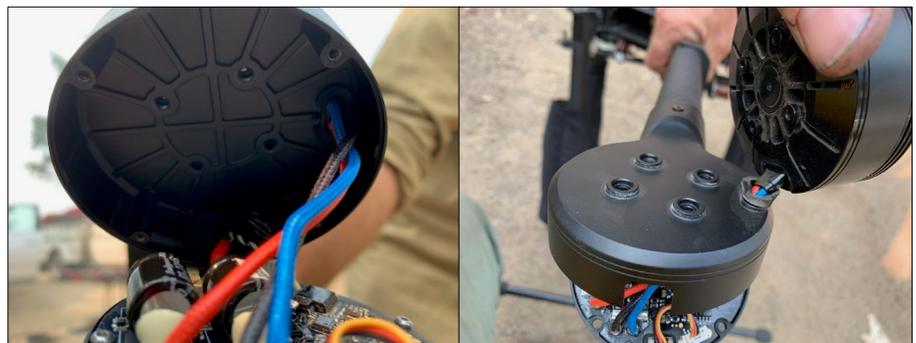
**Figure 1: Normal motor mount.**

All Department of Interior/US Forest Service (DOI/USFS) remote pilots are required to inspect the motor housing of all DJI M600 aircraft for any evidence of cracking around the four mount attachment points. If any cracks are discovered, the aircraft is grounded until a replacement mount can be installed. These cracks are most probable on aircraft that have experienced extensive use and/or been carrying heavy payloads.

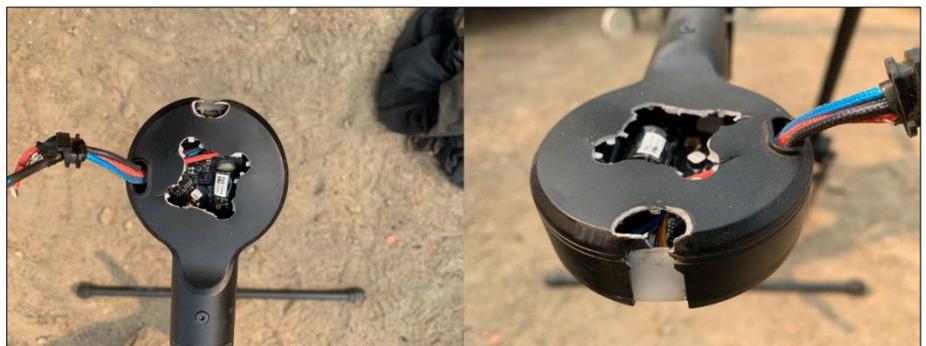
Initial post-crash inspection revealed that both aircraft were missing one of the motors at the 9 o'clock position. After an extensive search, neither motor was located. Additional evidence of small fractures on one of the motor housings strongly suggests that the motor broke free of the motor housing during flight. It is

It is suspected that metal fatigue played an integral role as the small fractures propagated over time until the motor finally broke free. Both mishap aircraft had experienced extensive use over the past two years.

**Figure 2: Motor mount after departure of motor.**

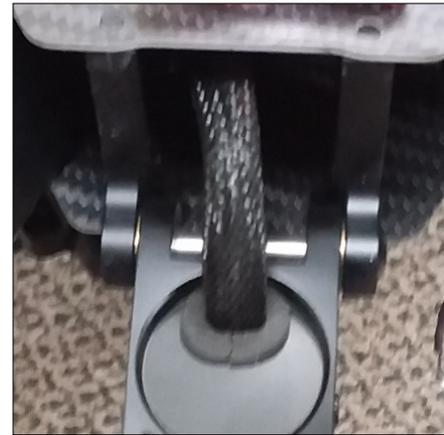
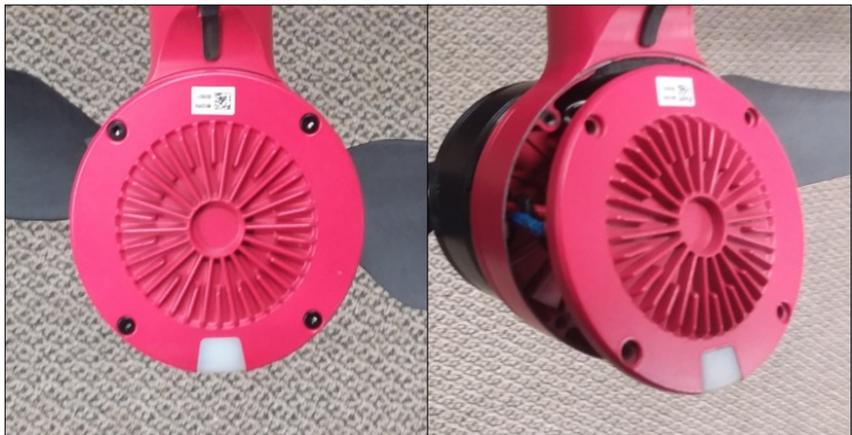
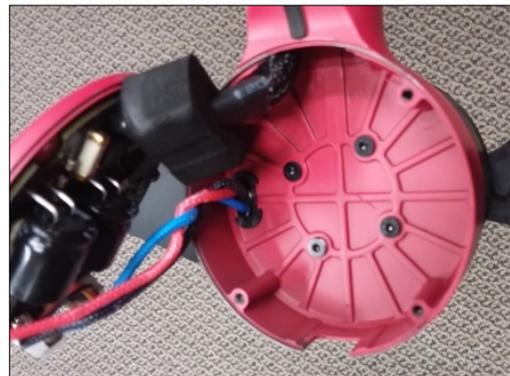
4. Locate **the foam plug and** gently pull the cable through. This will expose four screws that go in to the motor base. With a magnifying glass and light, inspect the area around each bolt head for signs of cracks or defects.

5. With the assistance of another person, inspect the exterior of the motor mount around each bolt looking for cracks. As one person is inspecting the exterior, the other person should carefully apply torque to the props. This is done in accordance with the training received in A-454, *Small UAS Operator Add-On Course*, in which you are testing that the motor is firmly mounted. If cracked, this action should reveal defects.

- 6. If a crack or defect is discovered, contact OAS and your National Aviation Office/Manager for assistance.
